# PHASE I ENVIRONMENTAL SITE ASSESSMENT

State of Idaho Department of Environmental Quality 1445 North Orchard Street Boise, Idaho 83706

Tetra Tech, Inc. 316 West Boone Avenue, Suite 363 Spokane, Washington 99201

September 19, 2017

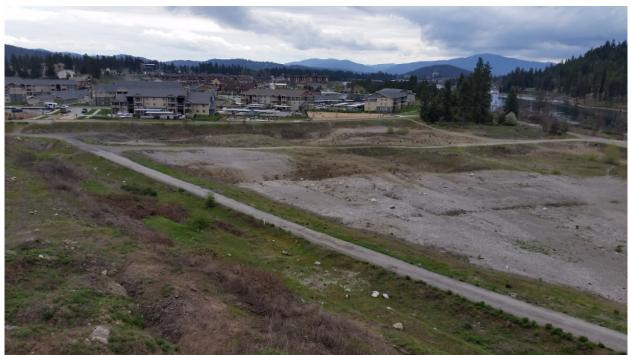
Photo 1: Looking southeast across the former lower log storage area on site (see Figure 3) and the former ROW of the NPRR. The area was scraped of top soil and debris, which was stockpiled on the northeast portion of the site. The Riverstone residential development and the North Idaho Centennial Trail are in the background.

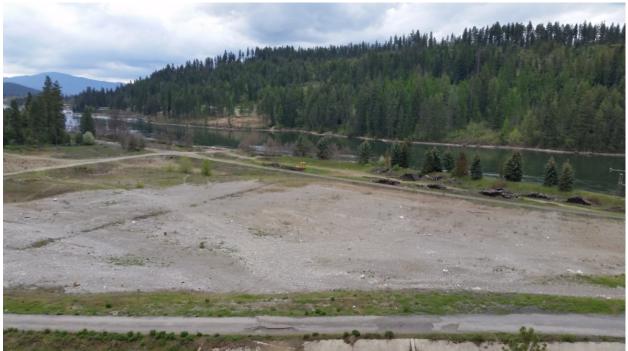
Photo 2: Panning right and looking generally southeast across the lower log storage area. The creosote logs stockpiled that appear once a part of the trestle spanning the canal on site rest within a former drainage feature (swale). The area does not appear to pool water. The west flowing (flowing to the right) Spokane River can be seen in the background.

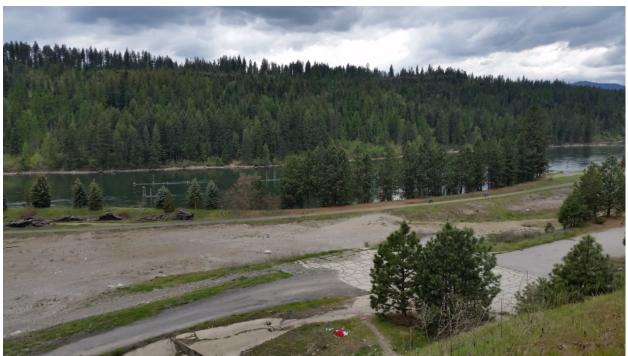
**Photo 3:** Panning right and looking southerly across the eastern central portion of the subject property. A partially concrete-lined drainage feature rests in the foreground. Water lines and utilities were observed behind trees on the lower right, but appeared disconnected and perhaps damaged.

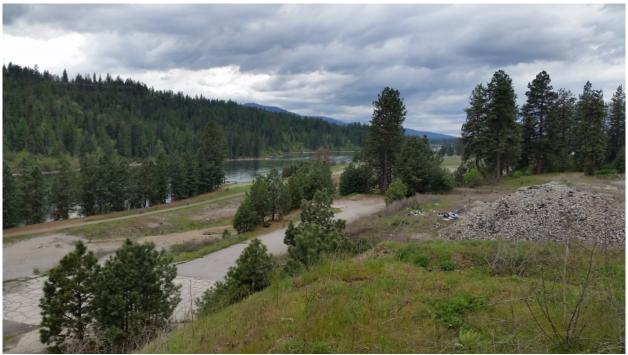
Photo 4: Panning right and looking southwest across the subject property from the apex of a hill consisting of woody debris from the former mill.

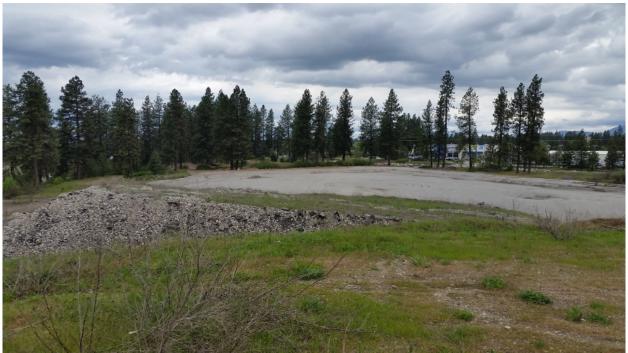
Photo 5: Panning right and looking west at the former upper log storage area on site. This area was once a pit that was later filled in with woody debris from the mill. The former truck scale is on the upper right of the photo. Stockpiled concrete and soil can be seen on the left.

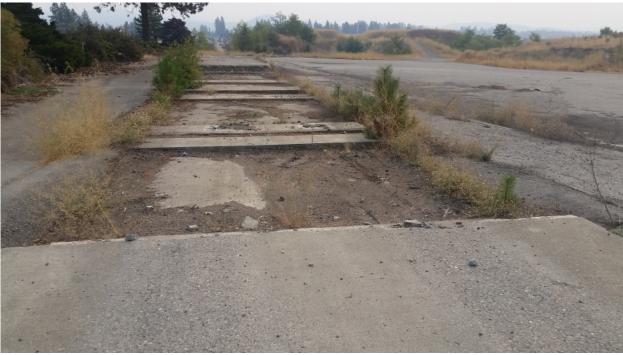
Photo 6: Looking east at the former truck scale area. The scales and related equipment appear to have been removed.

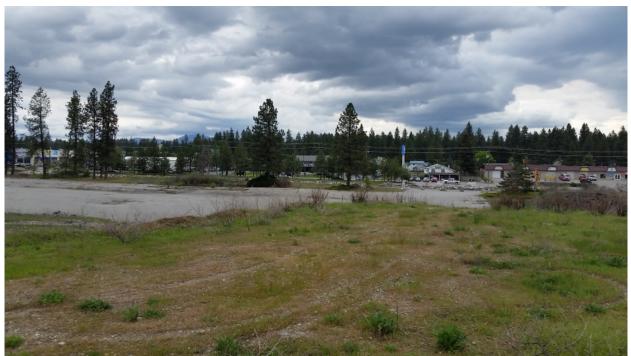
Photo 7: Panning right from Photo 5 and looking north across the northeastern portion of the subject property. The primary entrance to the site from West Seltice Way can be seen in the background. Further north are businesses along the north site of West Seltice Way, which is roughly 150 feet wide.

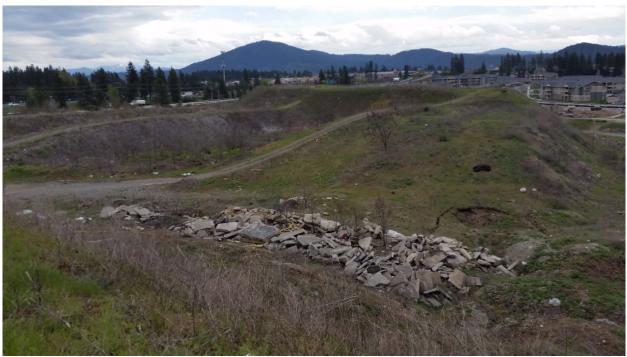
**Photo 8:** Panning right and looking easterly at the wood waste stockpile that also includes concrete debris. Subsidence is notable within the stockpile, which rises as much as 60 feet above surrounding landscape.

- The northeastern portion of the subject property was utilized for the purposes of stockpiling surface soil and woody debris that may have been affected by mill and nearby railroad operations through the years. While no evidence was uncovered suggesting that releases have occurred beyond a *de minimis* condition, the quality of soil and woody debris within large stockpiles on the northeast portion of the site remains questionable. Until further investigation and/or possible sampling reveals otherwise, the likelihood of elevated concentrations of hazardous materials and/or petroleum products resting in stockpiles and former pits is considered to represent a *recognized environmental condition* in connection with the subject property at this time.

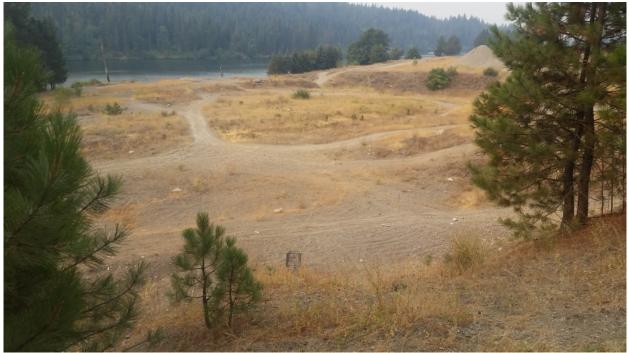
**Photo 10:** Looking southeast at the former aboveground storage tank area. This area was once used for refueling log trucks and included a 10,000 gallon diesel aboveground tank in secondary containment.

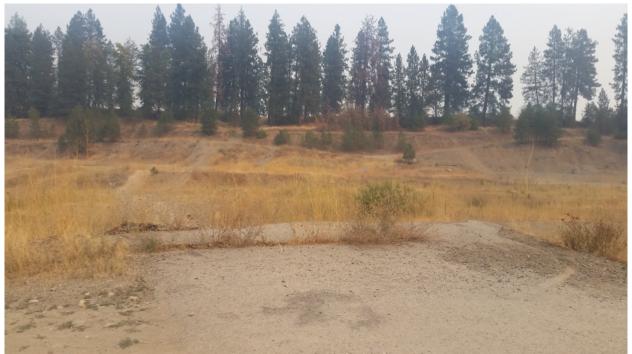
Photo 12: Looking north across the site opposite the position of Photo 11. This is an eastern portion of the former mill area just east of the canal.

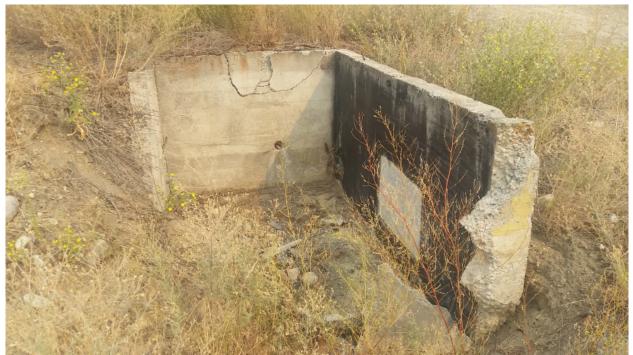
Photo 14: Looking at a former septic tank once located near the northern end of the sawmill building. Clay tile pipe was observed leading to this feature.

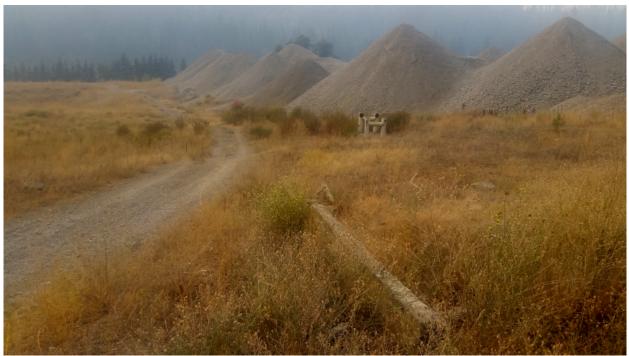
Photo 15: Looking south from the former septic tank (lower right) at the piles of crushed concrete proximal to the former mill location. The former canal is on the upper left of the photo.

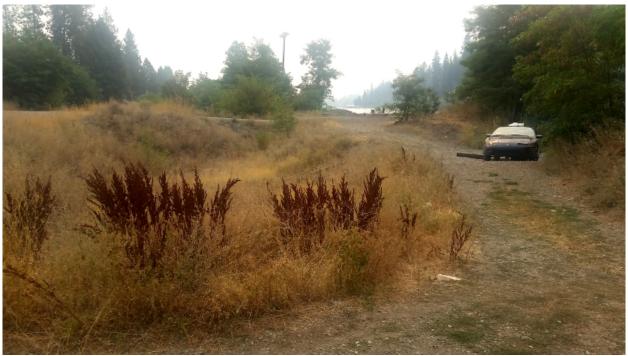
Photo 22: Looking southeast within the former long drainage swale once used by the mill for pollution prevention purposes. Portions of this feature appear to rest at an elevation that is below the current elevation of the river. The car on the right appeared abandoned.

Closure of the site to vehicles is recommended to prevent potential releases of fluids from stranded vehicles and other unregulated usages. Understanding the quality of topsoil and stockpiles on site may alleviate concerns with further earthwork.

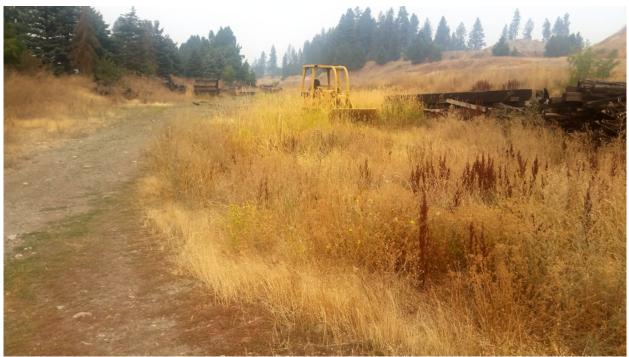
Photo 23: Looking northwesterly within the former swale area at a small bulldozer that also appears abandoned. Creosote log storage from the former trestle is located on the right.

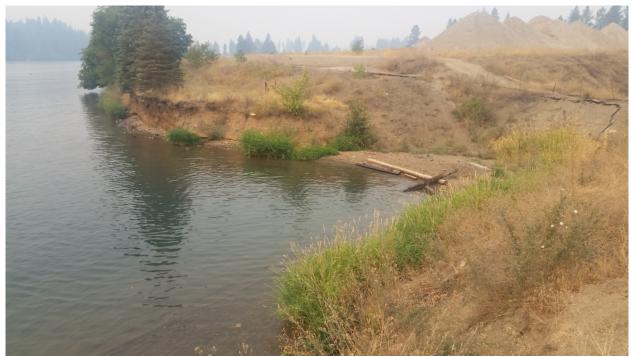
Photo 24: View to the west at the former canal entrance that was blocked with fill on the right.

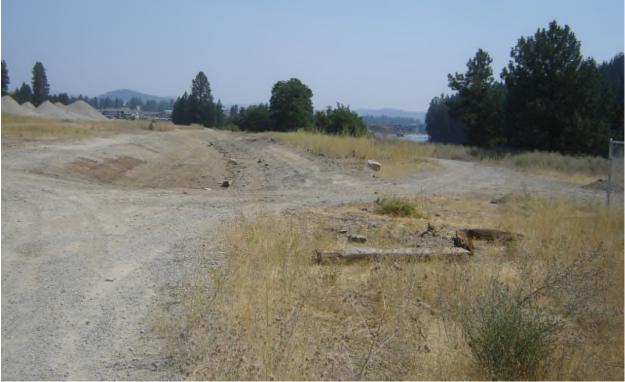
Photo 26: Looking west from City of Coeur d'Alene property that is former railroad ROW. The subject property rests on the north and south sides of this land. The dished area in the upper left was recently used to contribute to ballast for the West Seltice Way revitalization.

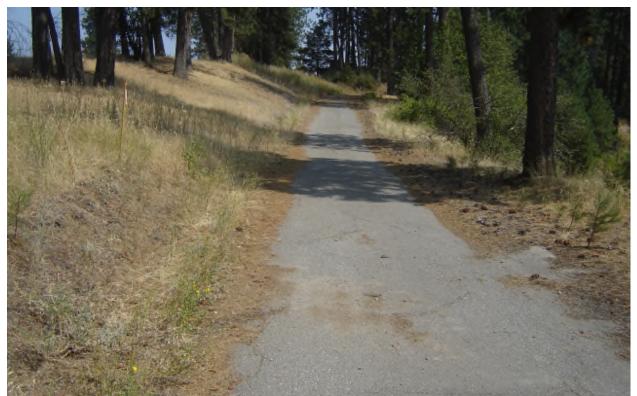
**Photo 28:** View east along the northwest boundary of the site. The roadway pictured appears to have once been the pathway of a railroad. This roadway leads to the Atlas Mill Development Corp. property that is considered a northern adjoining property.

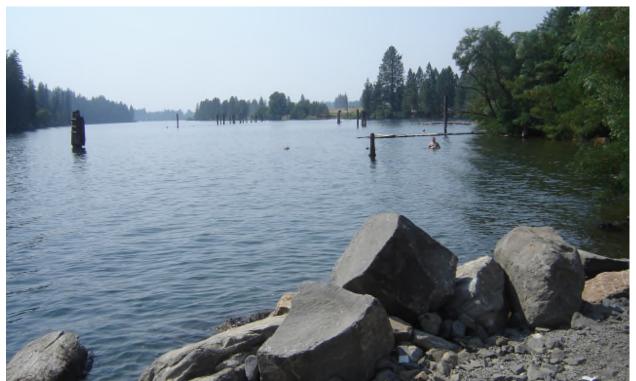
Photo 30: Looking westerly along the Spokane River at the pilings once used to herd logs into the canal area on site from the river.
